Property Inspection Report

14407 Coachway Drive, Centreville, VA 20120

Date of Inspection: 5/7/2020 Time: 10:00

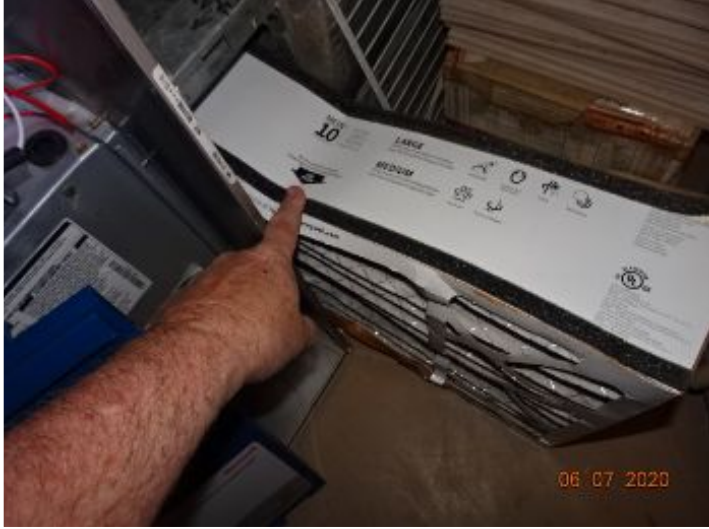
HVAC-1		
Page 12 Item: 1	HVAC Age and Location	<ul style="list-style-type: none">• This unit does not appear to have been serviced recently. We recommend that it be serviced and inspected by a licensed HVAC contractor.
Page 13 Item: 5	Filter	<ul style="list-style-type: none">• The filter is damaged and not covering the opening to the air handler. The filter should be replaced and properly installed to keep the equipment clean.

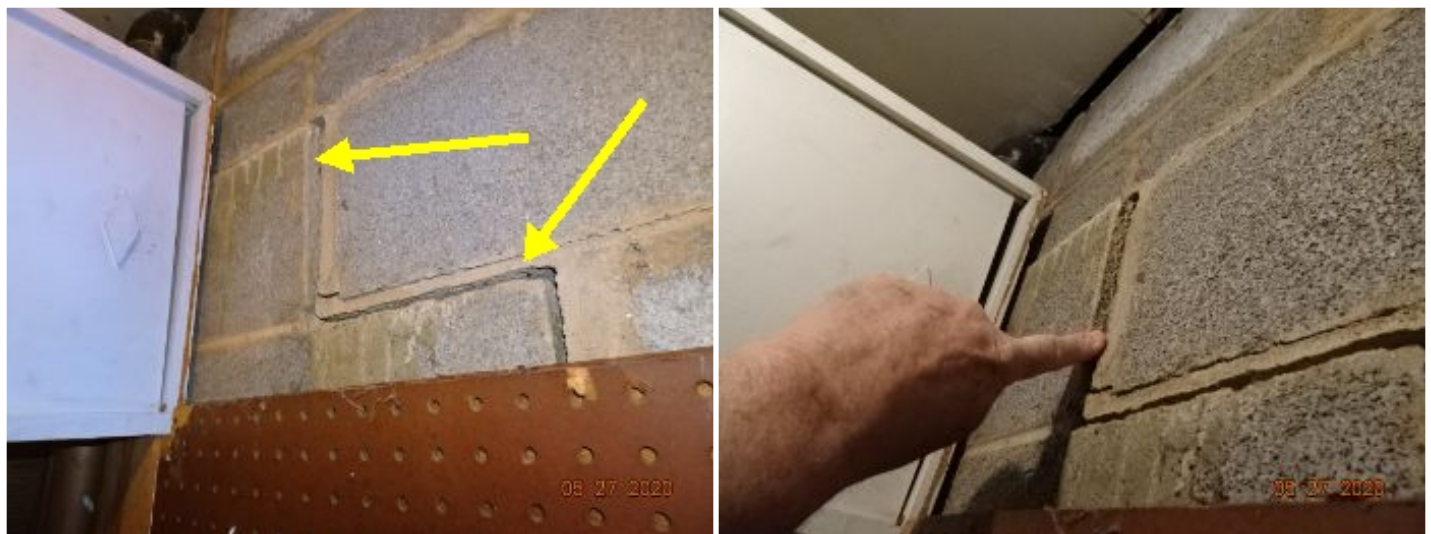
HVAC-2		
Page 16 Item: 1	HVAC Age and Location	<ul style="list-style-type: none">• The heating and cooling system is functional, but beyond its design life. Therefore, it will need to be more closely monitored, serviced bi-annually, and have its filters changed every month. You should budget for its replacement.
Basement Structure		
Page 19 Item: 2	Foundation Wall Type	<ul style="list-style-type: none">• The cracks in the basement foundation wall indicate significant movement. This can adversely affect the support of the structure. You should consult with a structural engineer, foundation contractor or other qualified professional as to what repairs are needed to ensure that the structure is properly supported.

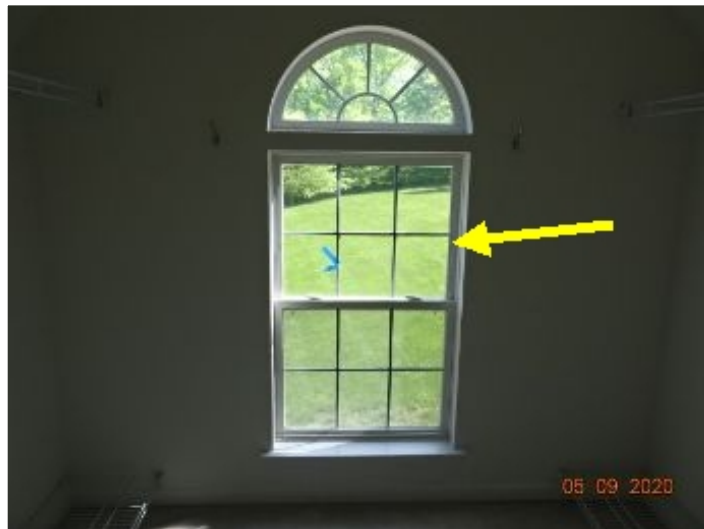
Page 30 Item: 1	Windows	<ul style="list-style-type: none"> One or more windows have a broken seal between the two panes of glass and should be replaced. This is evident from fogging, or condensation forming between the panes of glass, that confirms that the seal has failed. This will not only affect its appearance, but also its insulating ability.
-----------------	---------	--

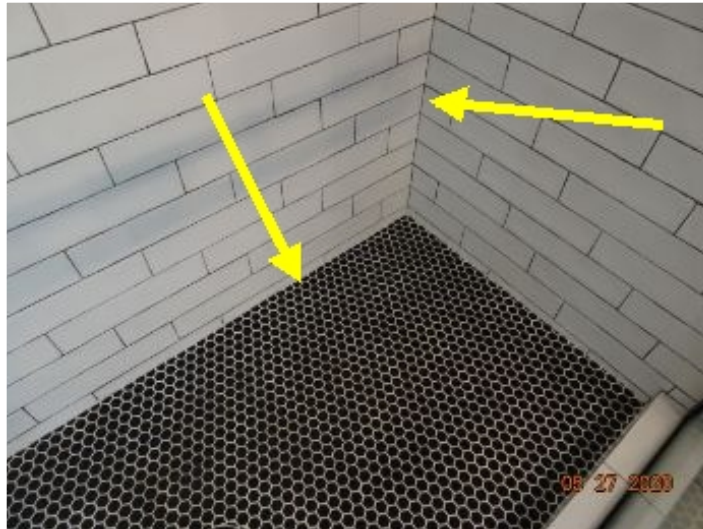
Page 31 Item: 7	Shower Stall	<ul style="list-style-type: none"> Caulking is needed around the shower enclosure. This is needed to keep water from getting into the wall around and floor in front of the enclosure. If water gets into these areas, it can cause the subfloor and supporting structure to deteriorate.
-----------------	--------------	--

Caulking is needed around the shower enclosure. This is needed to keep water from getting into the wall around and floor in front of the enclosure. If water gets into these areas, it can cause the subfloor and supporting structure to deteriorate.

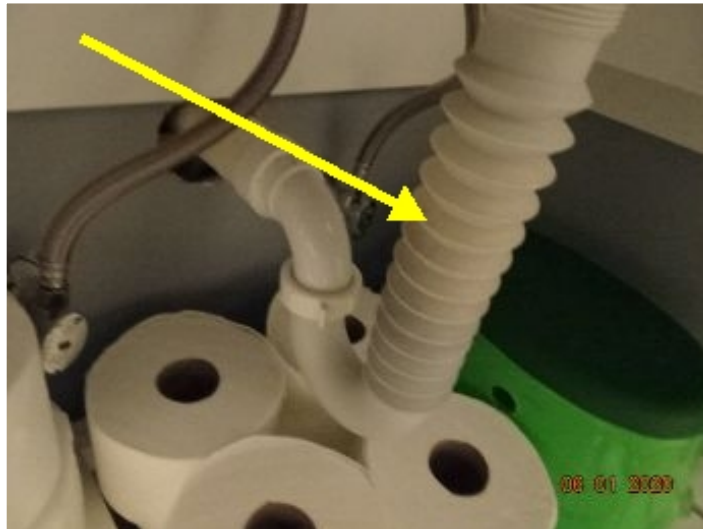
Page 33 Item: 4	Sink & Faucet	<ul style="list-style-type: none">• The sink employs a flexible drainpipe that could contribute to blockages and leaks. It should be replaced by a strait smooth walled pipe. The ridges can trap debris that will clog the drain. They also have a tendency to crack and leak.
-----------------	---------------	---

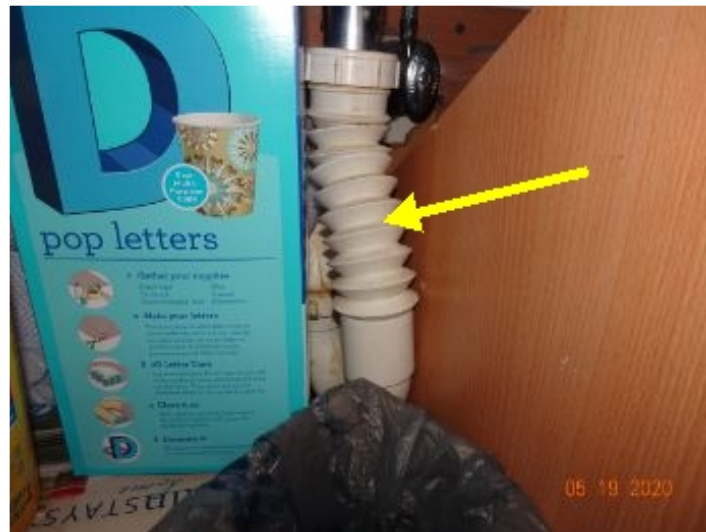
Page 34 Item: 4	Powder Room Sink & Faucet	<ul style="list-style-type: none">• The sink employs a flexible drainpipe that could contribute to blockages and leaks. It should be replaced by a strait smooth walled pipe. The ridges can trap debris that will clog the drain. They also have a tendency to crack and leak.• The sink drain is slow or partially blocked and should be serviced, to ensure that the blockage has not progressed beyond the trap and involved the main waste line.
-----------------	---------------------------	--

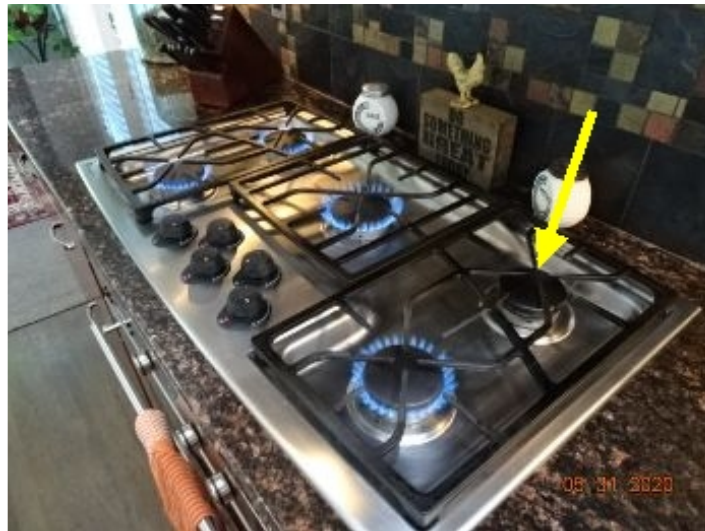
Page 35 Item: 2	Cooktop	• One or more of the burners of the cooktop did not come on when tested.
-----------------	---------	--

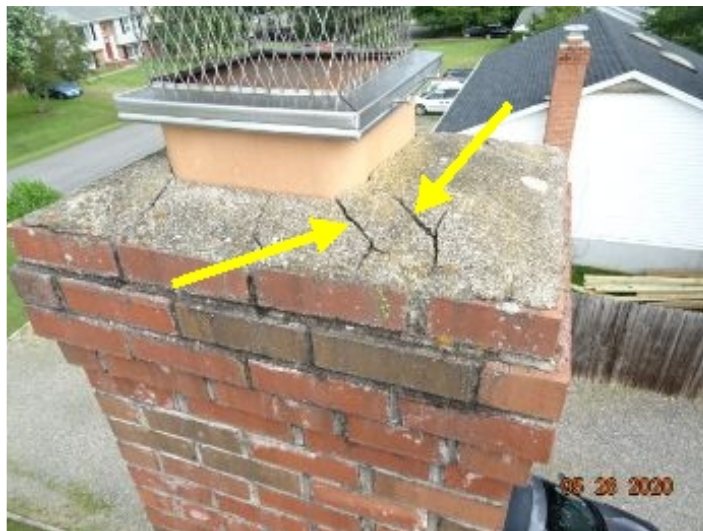
Page 41 Item: 6	Chimney Top	<ul style="list-style-type: none">• The crown, which is designed to seal the chimney wall and shed rainwater, is cracked and should be sealed.

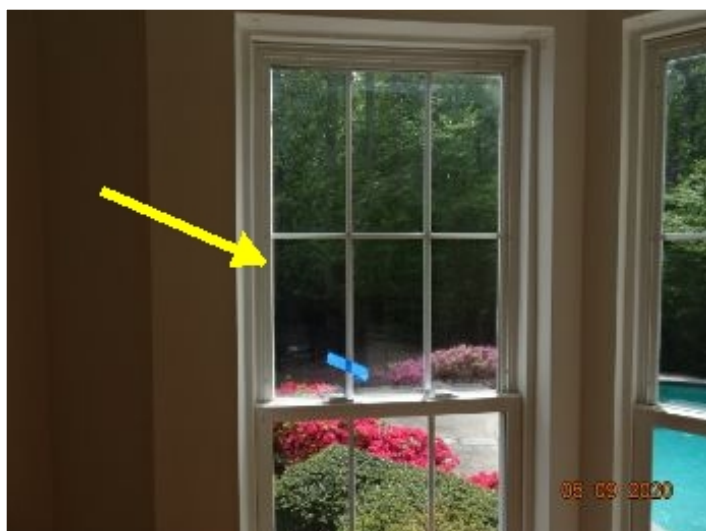
Page 41 Item: 1	Windows	<ul style="list-style-type: none">• One or more windows have a broken seal between the two panes of glass and should be replaced. This is evident from fogging, or condensation forming between the panes of glass, that confirms that the seal has failed. This will not only affect its appearance, but also its insulating ability.
-----------------	---------	--

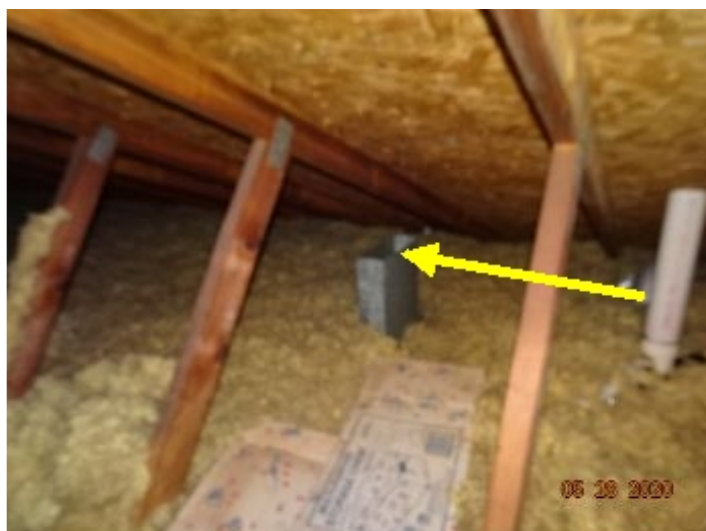
- The kitchen exhaust duct should be extended to an exterior port, through an outside wall or through the roof. If not vented properly they can allow excessive moisture to build up in the attic. This can damage the components of the roof and attic and allow mold to grow in the area.

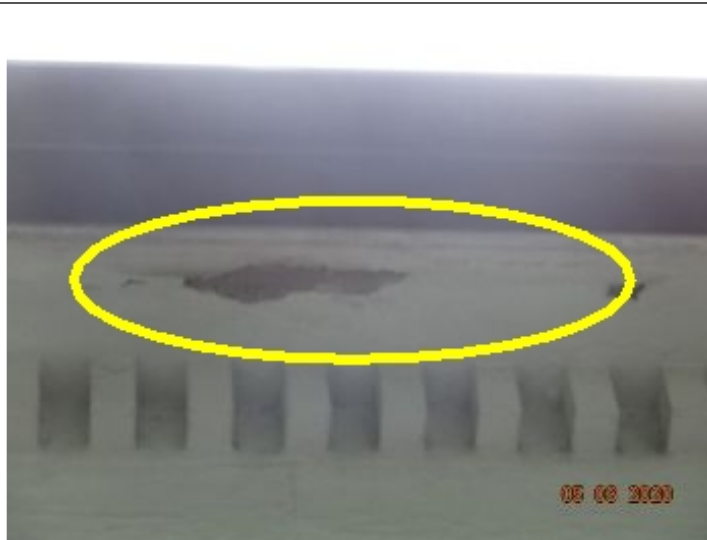
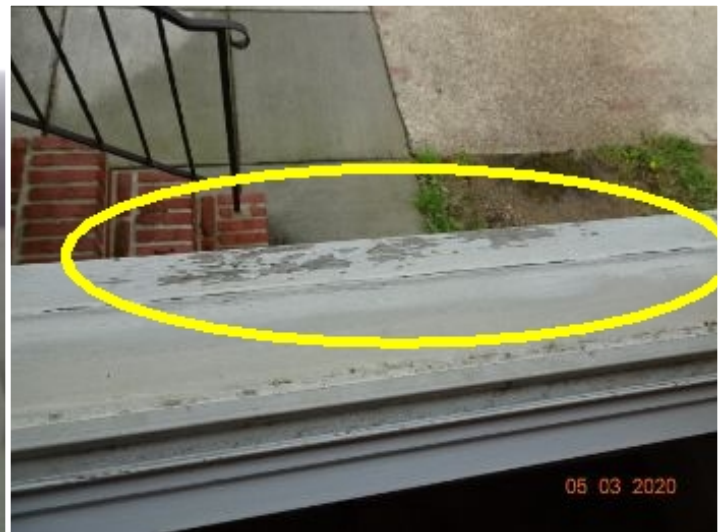
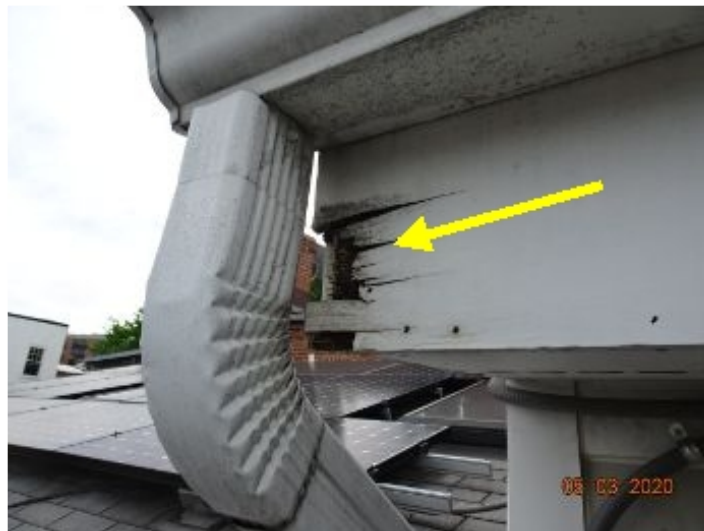
- The wooden fascia and trim on the outside of the house has peeling paint and rot. Any rotten or damaged wood should be replaced and repainted. This may be an indication of delayed or poor maintenance. There may be other areas that need repair that were not observed. Also the amount and depth of any moisture penetration cannot be determined until the damaged area is removed.

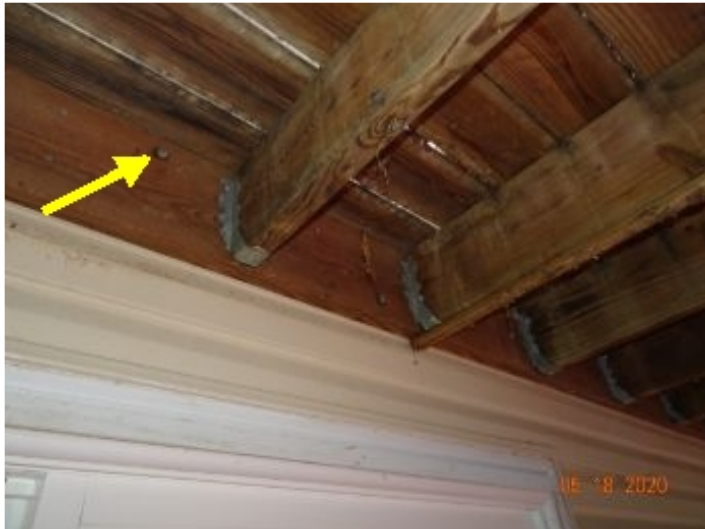
The bolts holding the deck ledger board are undersized by today's standards. The area should be monitored for any movement.

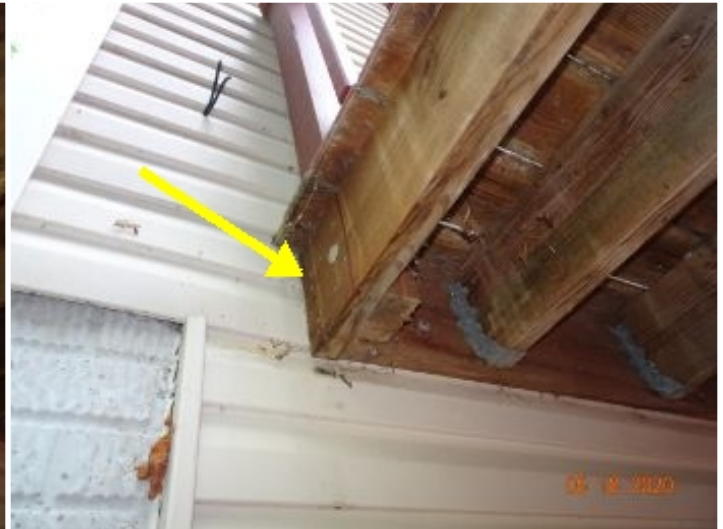
The deck ledger board, which attaches the deck to the house, has not been installed properly. It is installed on top of the siding. This can lead to premature deterioration in the area of the bolts that fasten the deck to the structure. The siding should have been cut away and the ledger board properly bolted directly to the structure with the proper flashing. The area should be monitored for any movement, deterioration and/or moisture intrusion because these are indicators that more support is needed and possibly repairs to the structure.

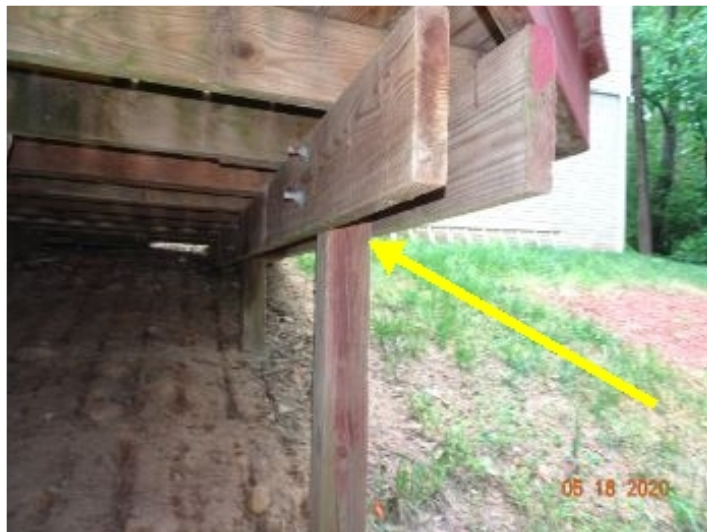
The deck beams are improperly attached to the support posts. The posts must fully support the downward weight of the deck. As such, beams attached to the sides of the support posts, as opposed to resting in notches in the post itself, cannot be expected to fully support the weight of the deck. This is a significant safety hazard and should be corrected to avoid potential deck collapse.

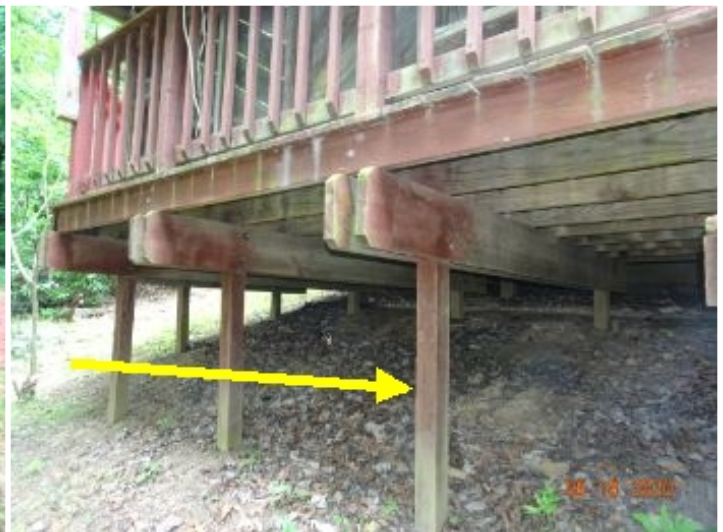
The post holding up the deck are made with 4 x 4 post. The current minimum acceptable size is a 6 x 6. More support should be added to keep the deck safe.

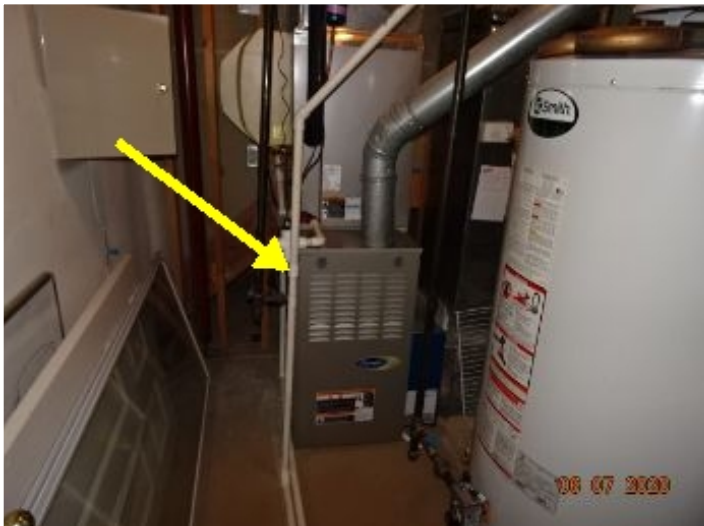
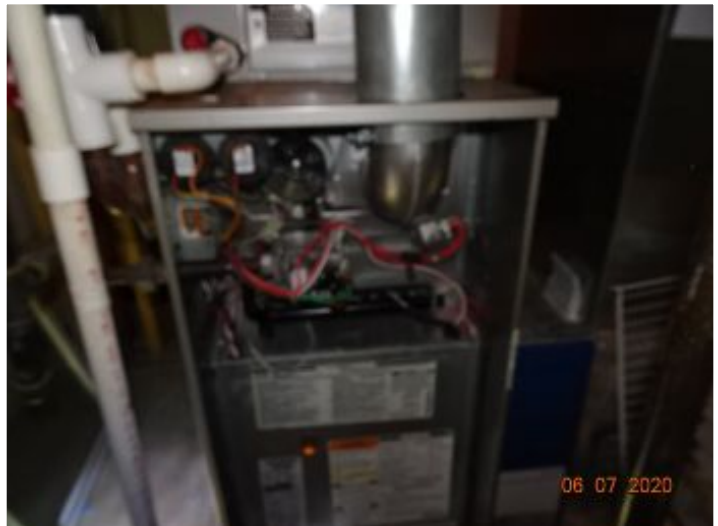
- This unit does not appear to have been serviced recently. We recommend that it be serviced and inspected by a licensed HVAC contractor.

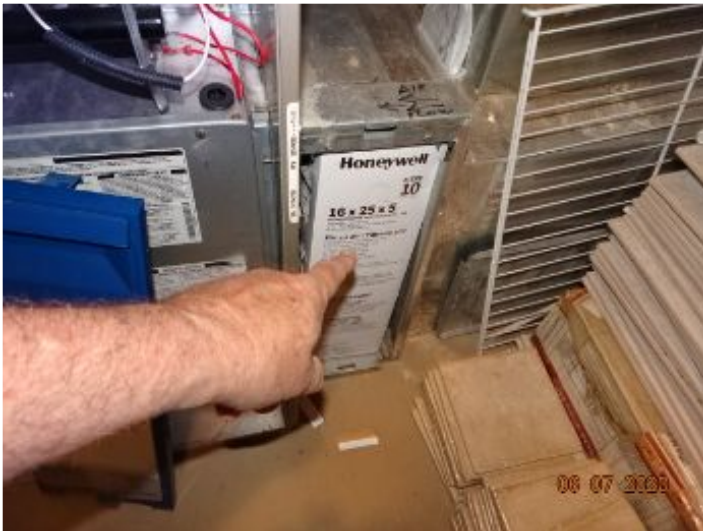
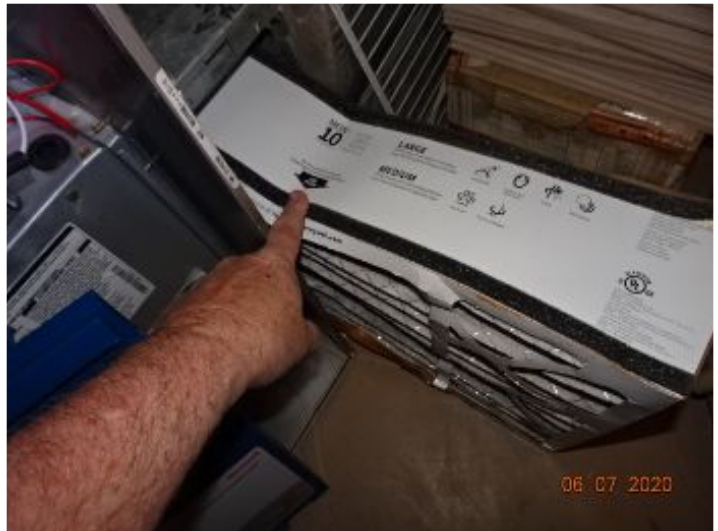
- The filter is damaged and not covering the opening to the air handler. The filter should be replaced and properly installed to keep the equipment clean.

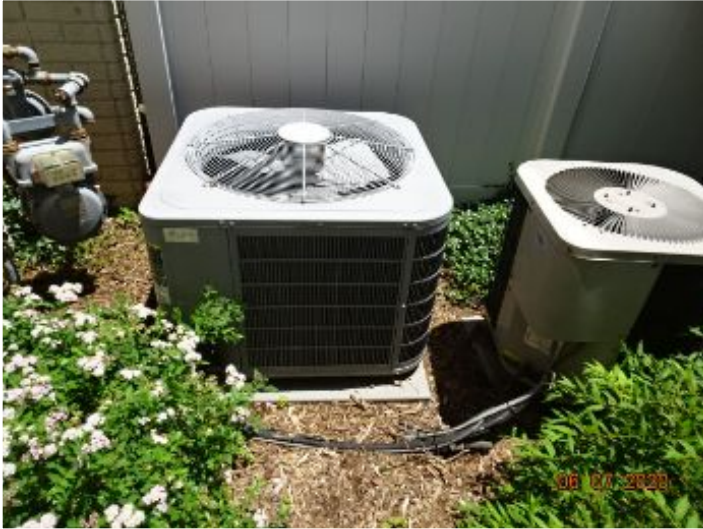
- The condensing coil responded to the thermostat and appears to be functional.

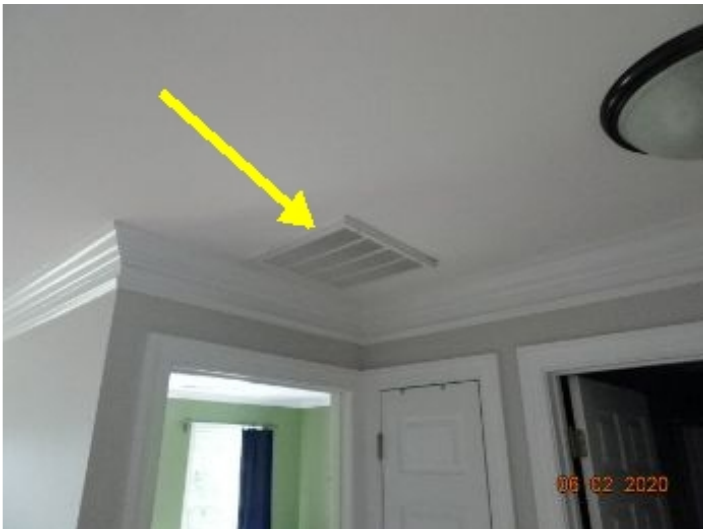
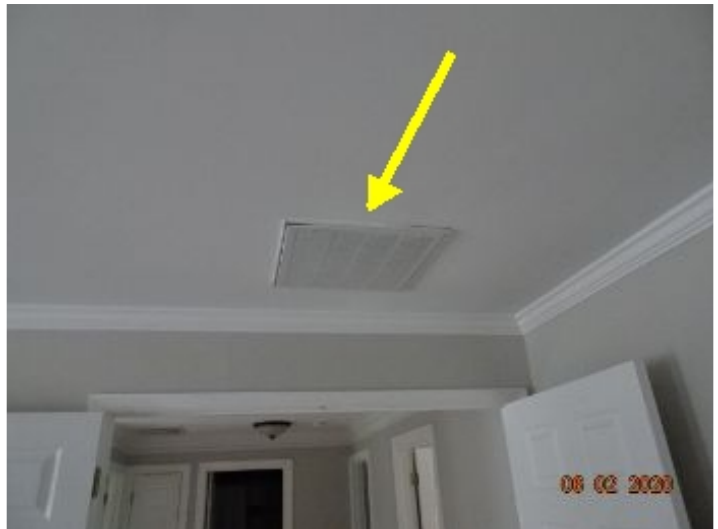
- This system has a disposable filter that should be changed approximately once a month. They can usually be purchased at most hardware stores.

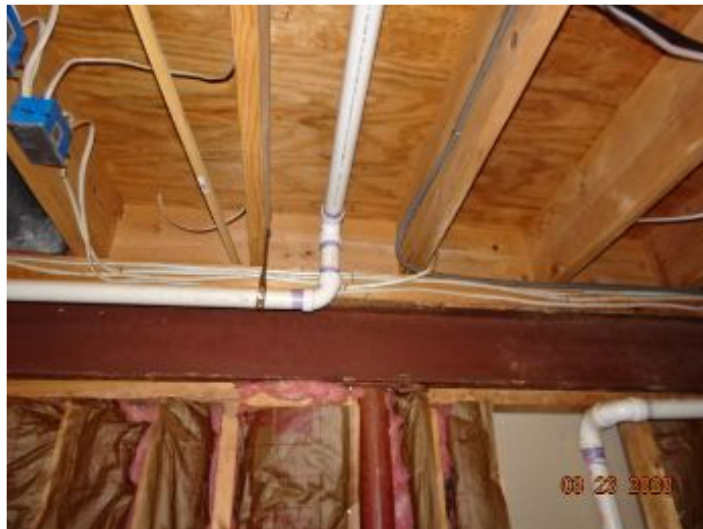
- The floor structure, that can be seen, includes structural steel beams and conventional lumber sheathed with plywood or OSB. This means that the floors inside of the foundation walls are supported by steel beams which support floor joist that are made with conventional lumber, such as 2x6s, 2x8, 2x12 and such. These support the sub-floor of plywood or OSB.

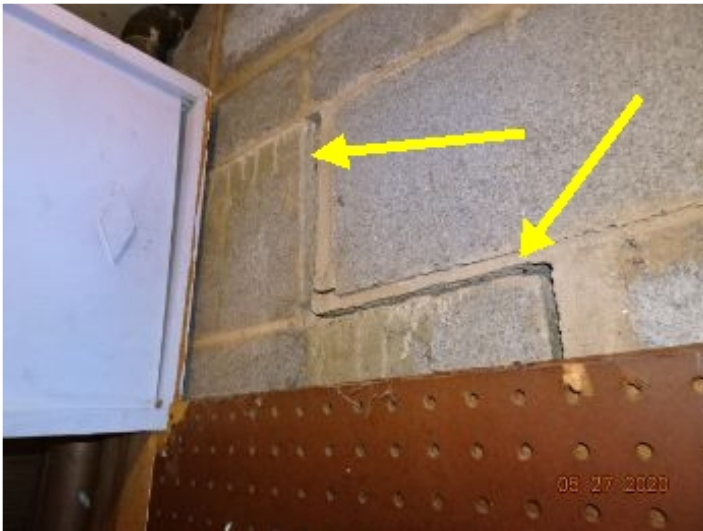
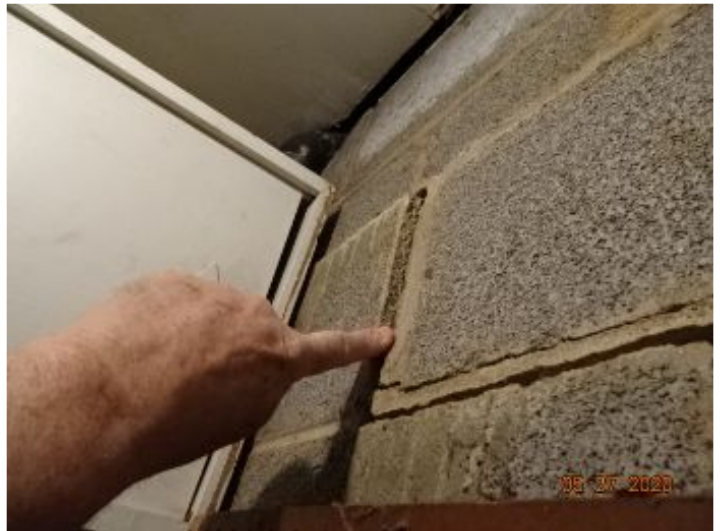
- The cracks in the basement foundation wall indicate significant movement. This can adversely affect the support of the structure. You should consult with a structural engineer, foundation contractor or other qualified professional as to what repairs are needed to ensure that the structure is properly supported.

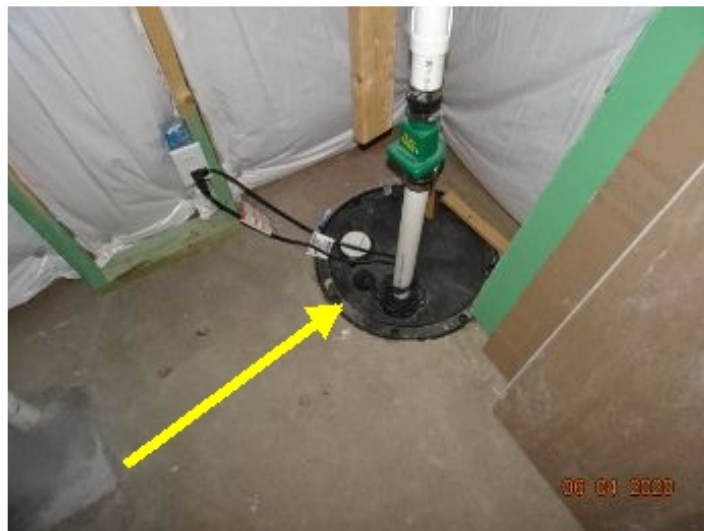
- This residence appears to be built with a drain system under the basement slab that directs water to a sump equipped with a sump pump. The sump pump was tested and appears to be working properly.

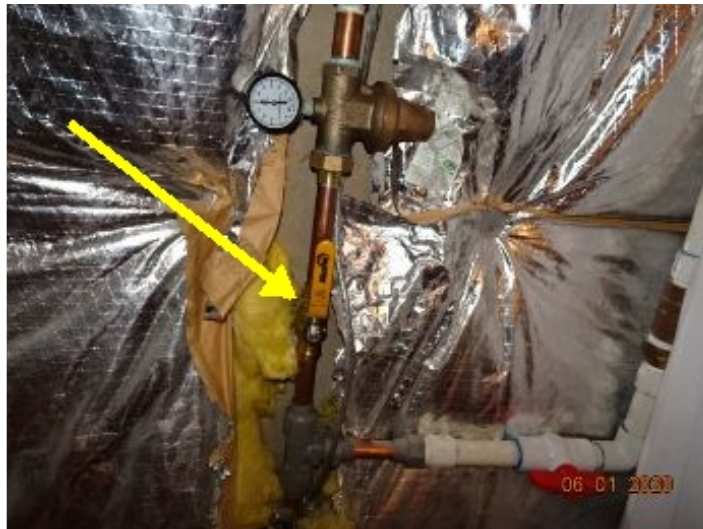
Main Water Cutoff Valve

- The main water shut-off is located on/in the utility room.
- The residence is on a public water system. The quality of the water is controlled by the utility supplying it. You may wish to have it tested for purity.
- The waste water from the residence is drained to a public system. This system is the responsibility of the utility in your area. Your responsibility is the household drains and the drain line in your yard that connects to the utilities line. This inspection check for normal drainage at the plumbing drains. The buried lines can become clogged or broken, particularly in older homes. You may wish to have the lines video scoped by a licensed plumber.

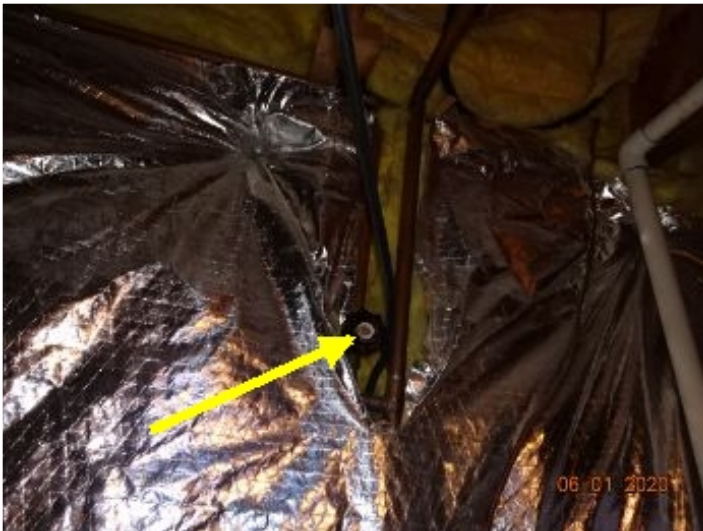
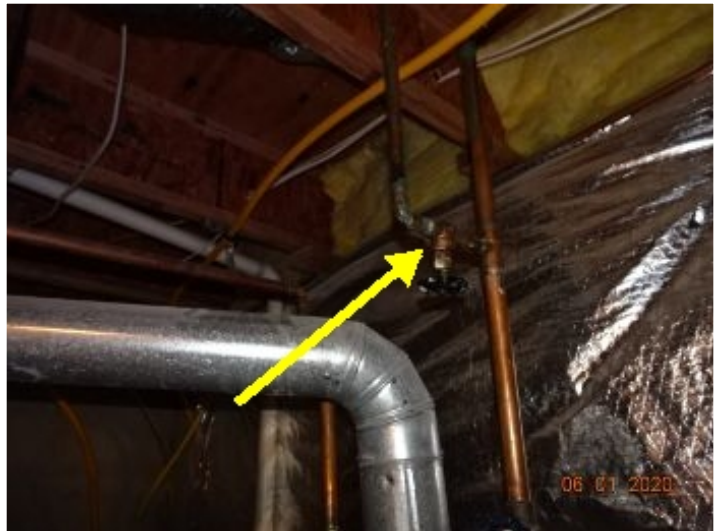
- We believe that we have found all the interior cut off valve for the outside water valve and they appear to be in good working order. There may be others that we were not able to find.

- The hose bibbs are functional, but we may not have located and tested every one on the property.

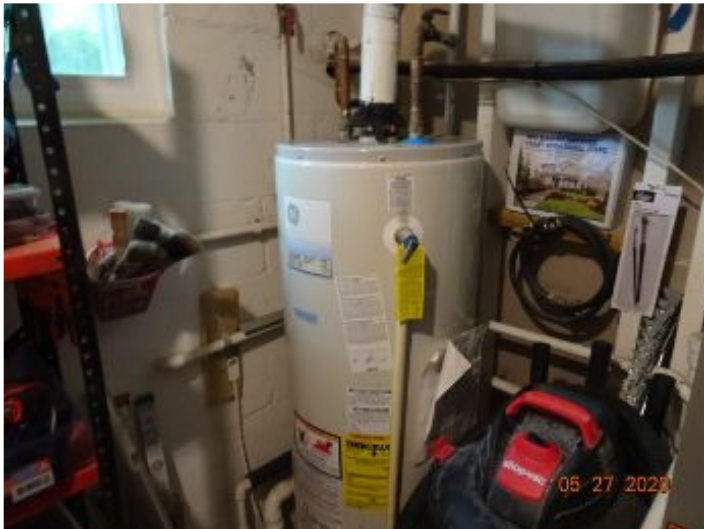
- This water heater is at or near the end of its expected life span. It should not be expected to last much longer. Although there is no way to know how much longer it will last. You should monitor it for signs of rust and leaking, as these are signs that it will need to be replaced.

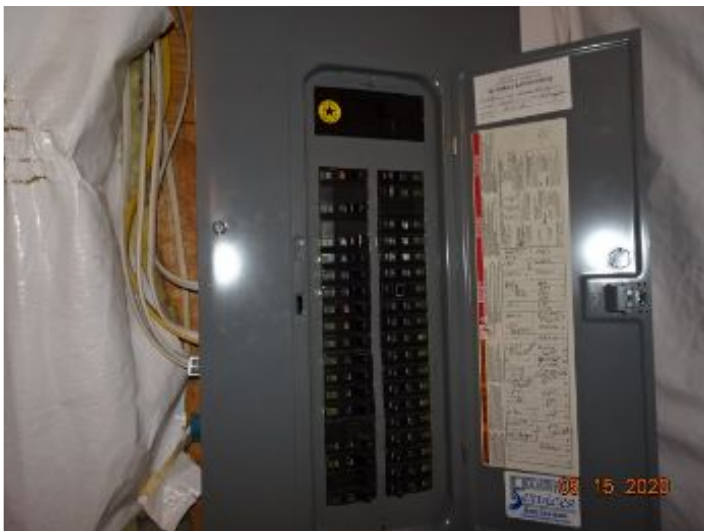
- The panel and its components have no visible deficiencies. But, you should check that the circuits are properly labeled. This is usually done by turning each breaker off and on to see what it operates.

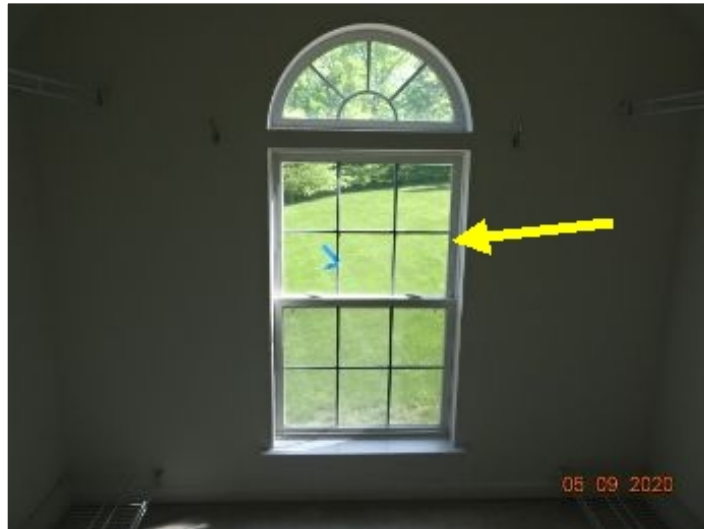
- One or more windows have a broken seal between the two panes of glass and should be replaced. This is evident from fogging, or condensation forming between the panes of glass, that confirms that the seal has failed. this will not only affect it's appearance, but also it's insulating ability.

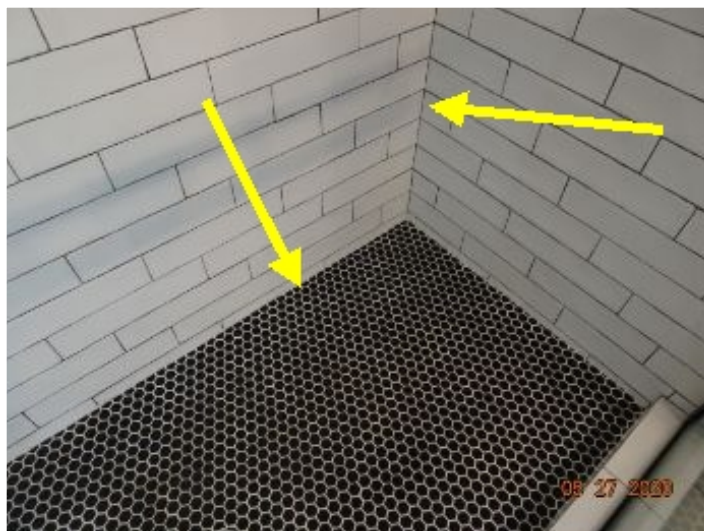
- [Caulking is needed around the shower enclosure. This is needed to keep water from getting into the wall around and floor in front of the enclosure. If water gets into these areas, it can cause the subfloor and supporting structure to deteriorate.](#)

Caulking is needed around the shower enclosure. This is needed to keep water from getting into the wall around and floor in front of the enclosure. If water gets into these areas, it can cause the subfloor and supporting structure to deteriorate.

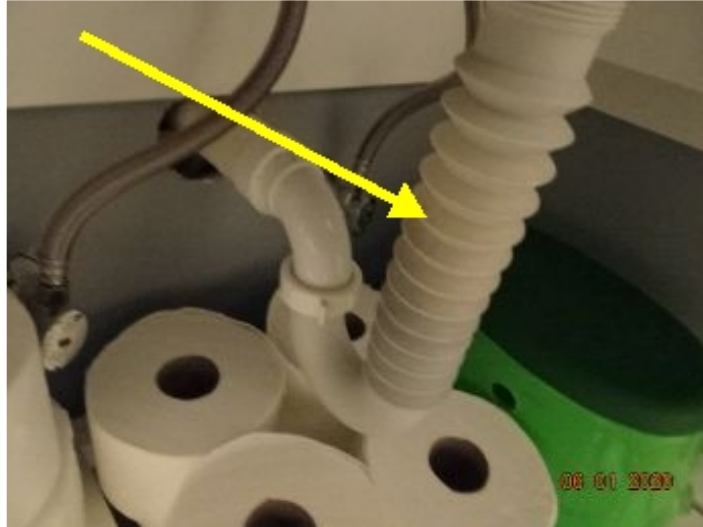
- The sink employs a flexible drainpipe that could contribute to blockages and leaks. It should be replaced by a strait smooth walled pipe. The ridges can trap debris that will clog the drain. They also have a tendency to crack and leak.

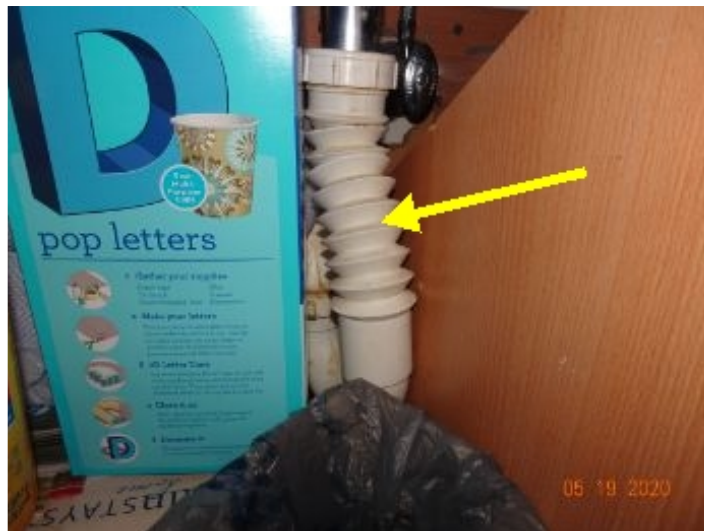
- The sink employs a flexible drainpipe that could contribute to blockages and leaks. It should be replaced by a strait smooth walled pipe. The ridges can trap debris that will clog the drain. They also have a tendency to crack and leak.
- The sink drain is slow or partially blocked and should be serviced, to ensure that the blockage has not progressed beyond the trap and involved the main waste line.

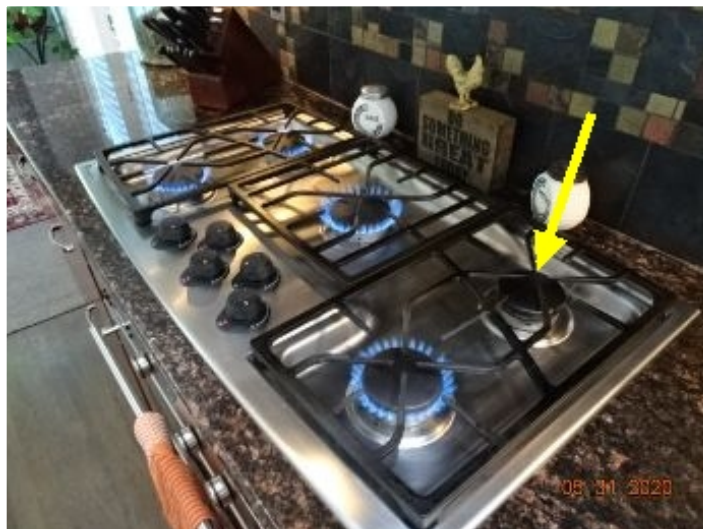
- One or more of the burners of the cooktop did not come on when tested.

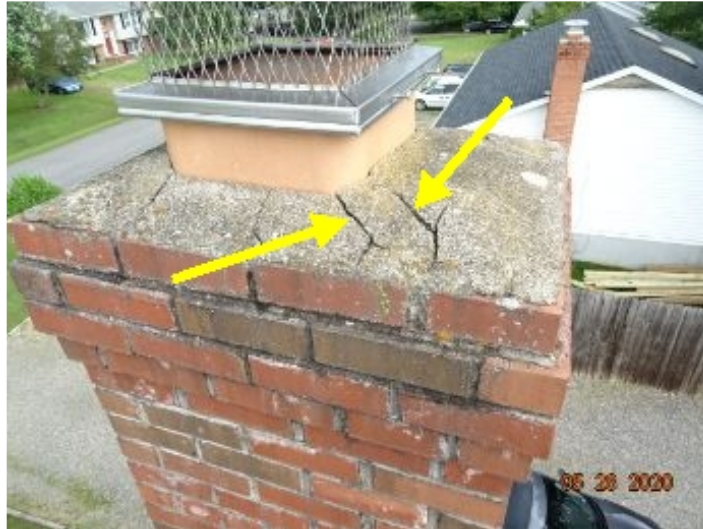
- The crown, which is designed to seal the chimney wall and shed rainwater, is cracked and should be sealed.

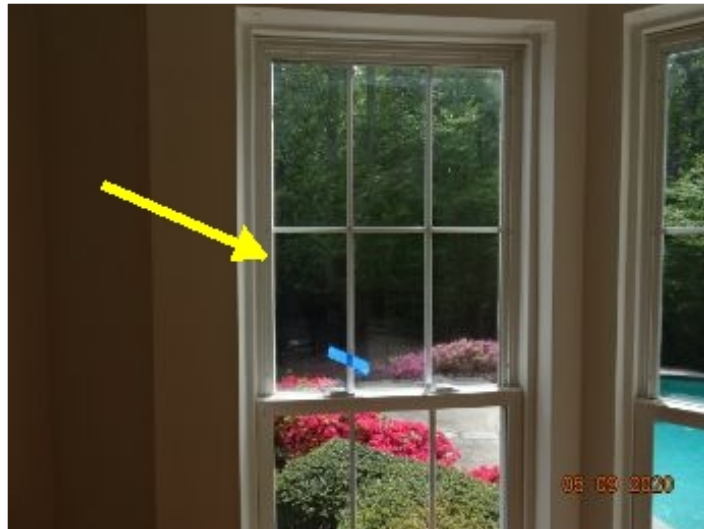
- One or more windows have a broken seal between the two panes of glass and should be replaced. This is evident from fogging, or condensation forming between the panes of glass, that confirms that the seal has failed. this will not only affect it's appearance, but also it's insulating ability.

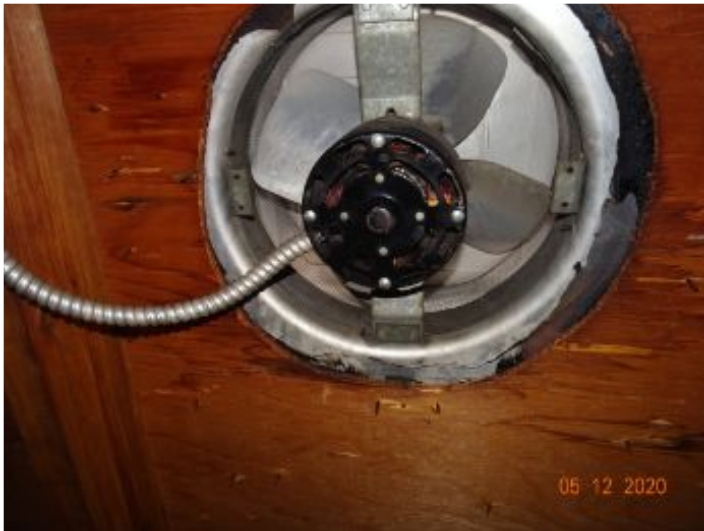
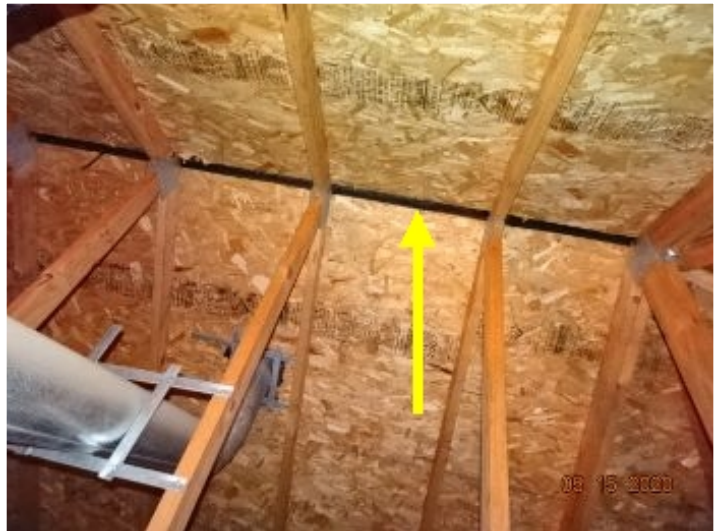
Ridge Vent

- Most attics today are the vented type. This means that the attic is not part of the "conditioned space" of the house. There should be insulation on the floor of the attic. If it is properly vented it will keep the temperature down in the summer, helping keep the house cooler. In the winter a properly vented attic will help stop ice damming by letting any snow cover melt evenly. Some attics are not vented, but are part of the "conditioned space" of the house. These will have the insulation on the bottom of the roof instead of on the attic floor.
- The attic is ventilated by vents in the soffit and ridge. Warmer air rises out of the ridge vent and cooler air enters at the soffit vents.
- The attic has one or more power vents. These vents have a fan to exhaust hot air from the attic. The fan is controlled by a thermostat switch to turn the fan on at a preset temperature.

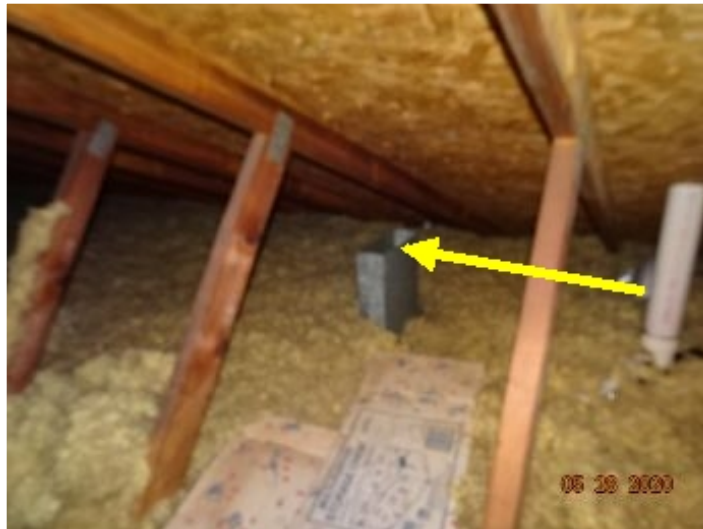
- The kitchen exhaust duct should be extended to an exterior port, through an outside wall or through the roof. If not vented properly they can allow excessive moisture to build up in the attic. This can damage the components of the roof and attic and allow mold to grow in the area.

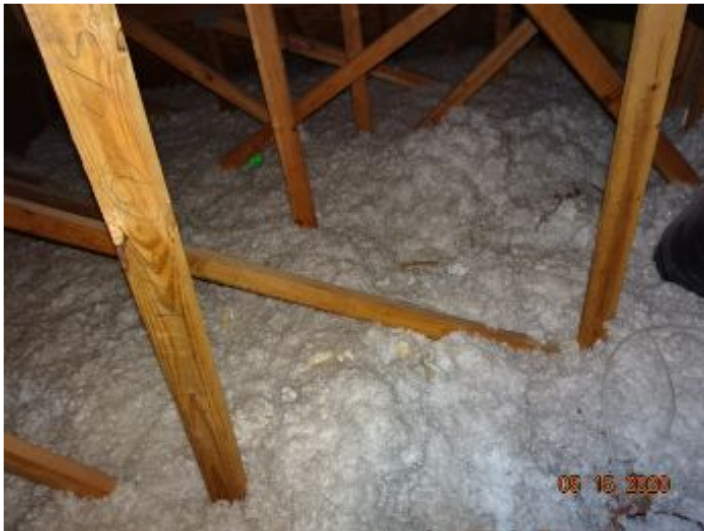
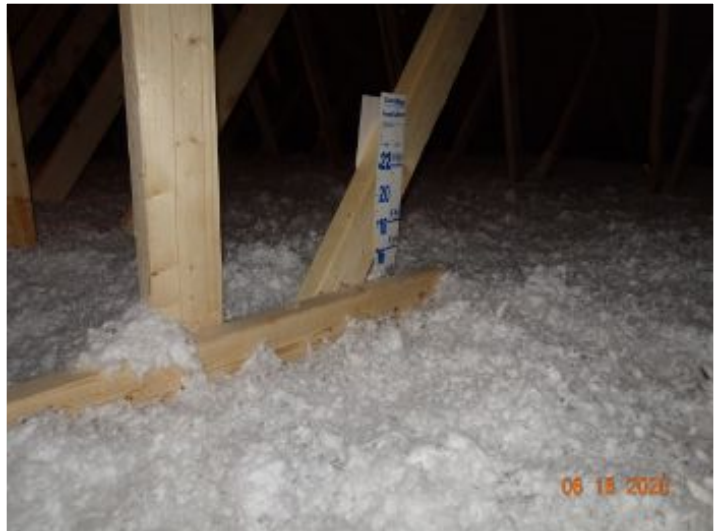
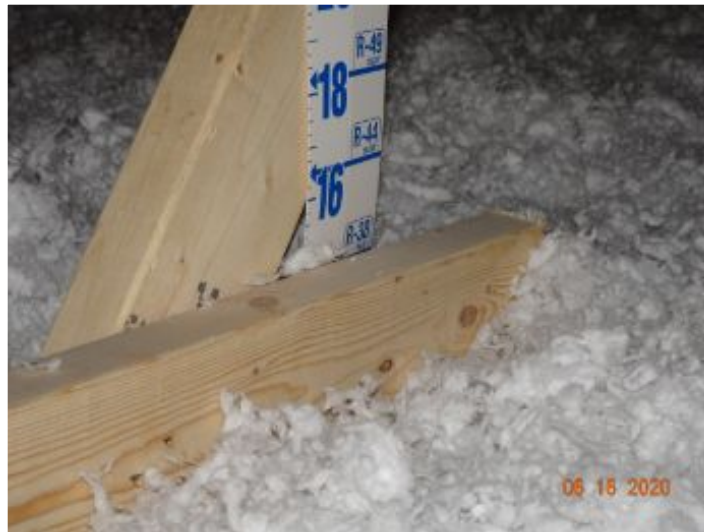
- There is eight to twelve inches of blown-in fiberglass insulation in the attic area. This generally considered to be a good amount of insulation.

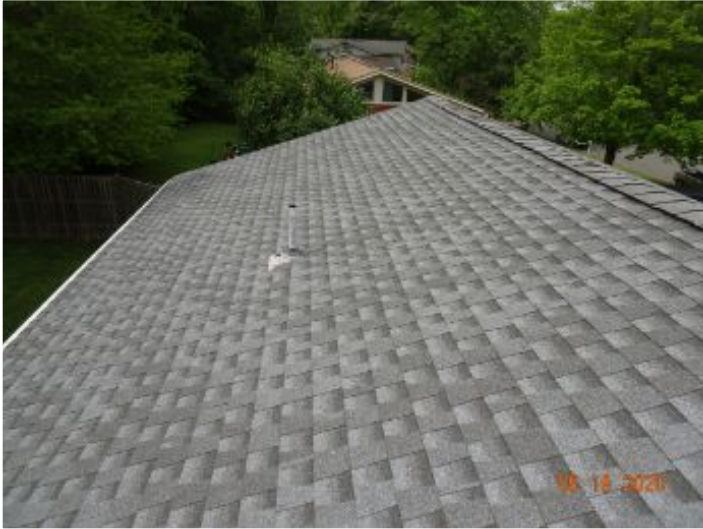
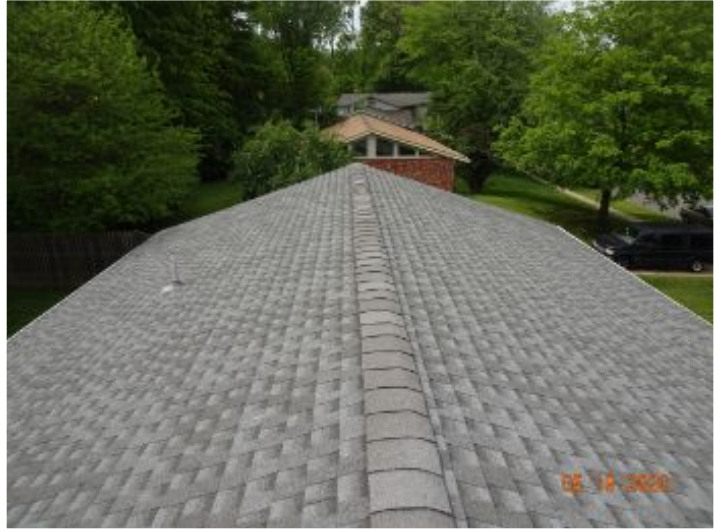
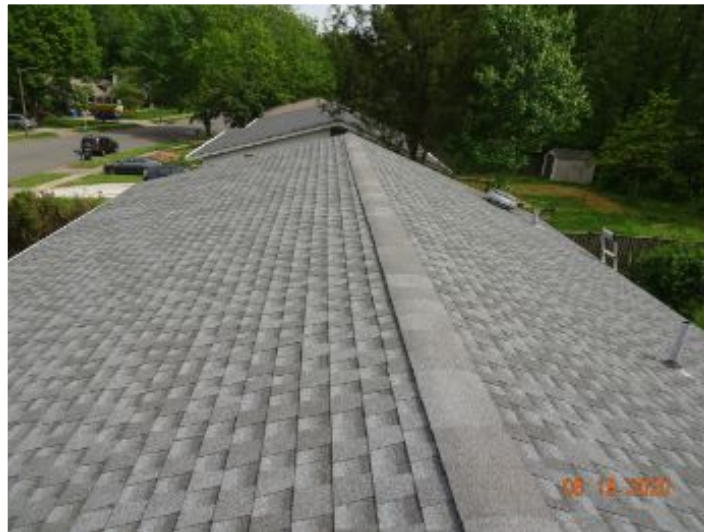
- The roof appear to be approximately five to ten years old, but this is just an estimate and you should request the installation permit from the sellers, which will reveal its exact age and any warranty guarantee that might be applicable.
