Property Inspection Report

14407 Coachway Drive, Centreville, VA 20120

Date of Inspection: 5/7/2020 Time: 10:00

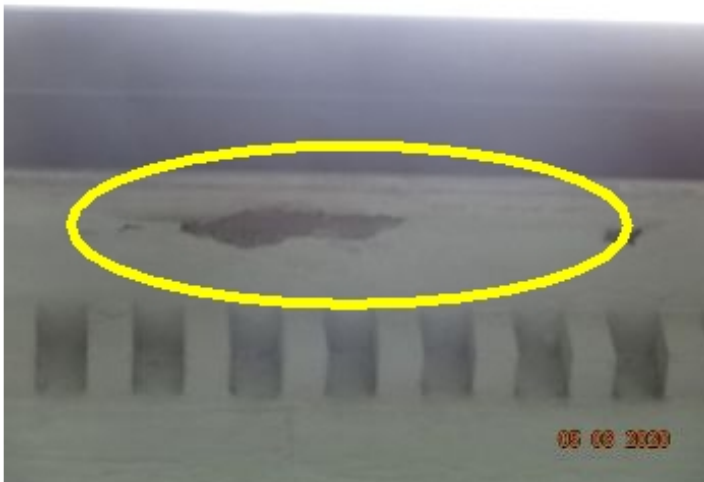
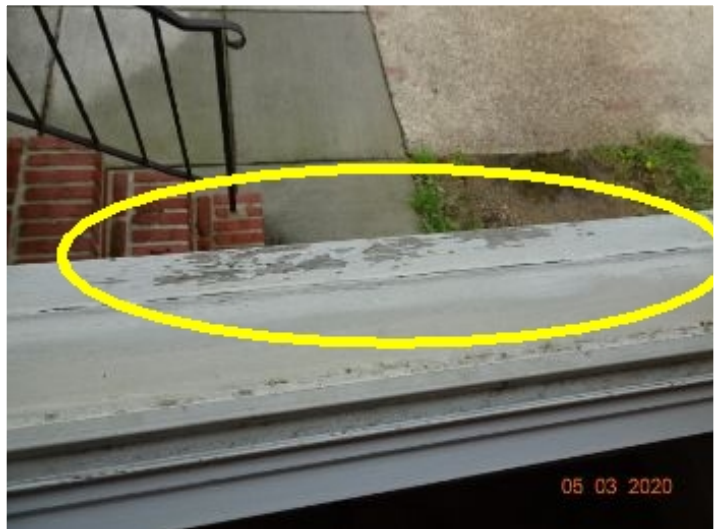
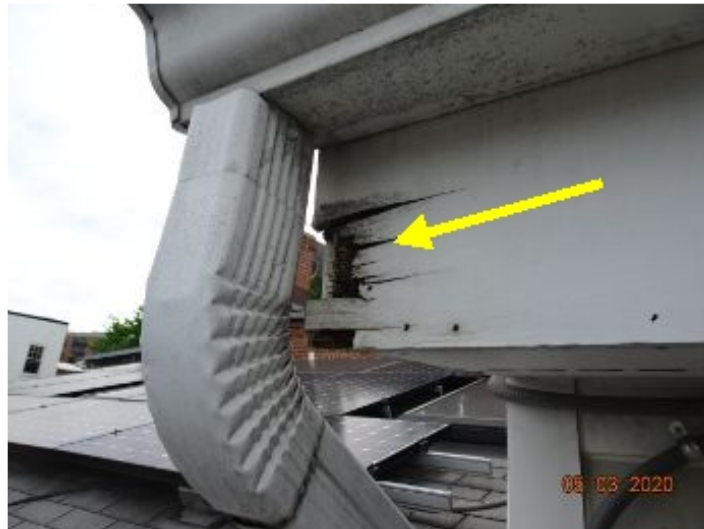
- The wooden fascia and trim on the outside of the house has peeling paint and rot. Any rotten or damaged wood should be replaced and repainted. This may be an indication of delayed or poor maintenance. There may be other areas that need repair that were not observed. Also the amount and depth of any moisture penetration cannot be determined until the damaged area is removed.

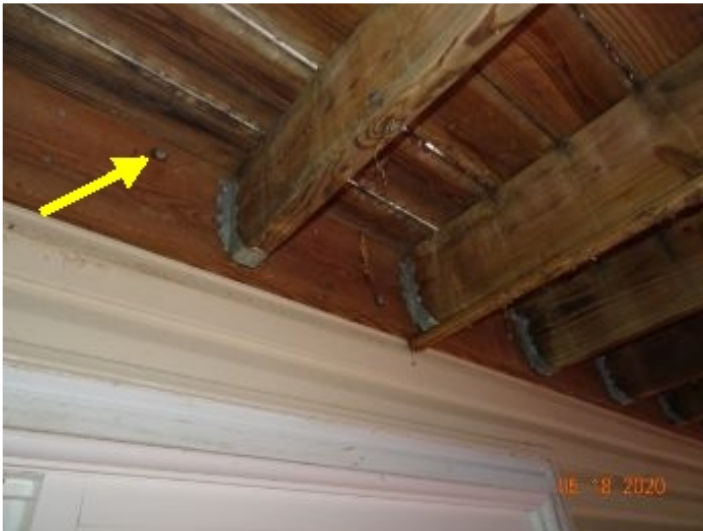
The bolts holding the deck ledger board are undersized by today's standards. The area should be monitored for any movement.

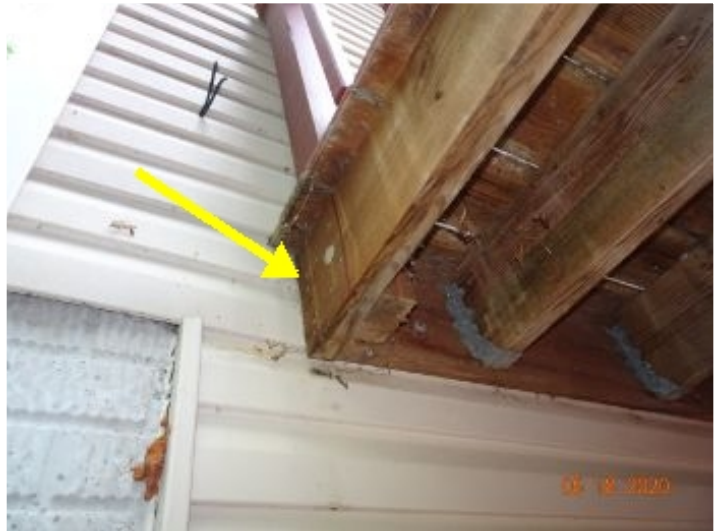
The deck ledger board, which attaches the deck to the house, has not been installed properly. It is installed on top of the siding. This can lead to premature deterioration in the area of the bolts that fasten the deck to the structure. The siding should have been cut away and the ledger board properly bolted directly to the structure with the proper flashing. The area should be monitored for any movement, deterioration and/or moisture intrusion because these are indicators that more support is needed and possibly repairs to the structure.

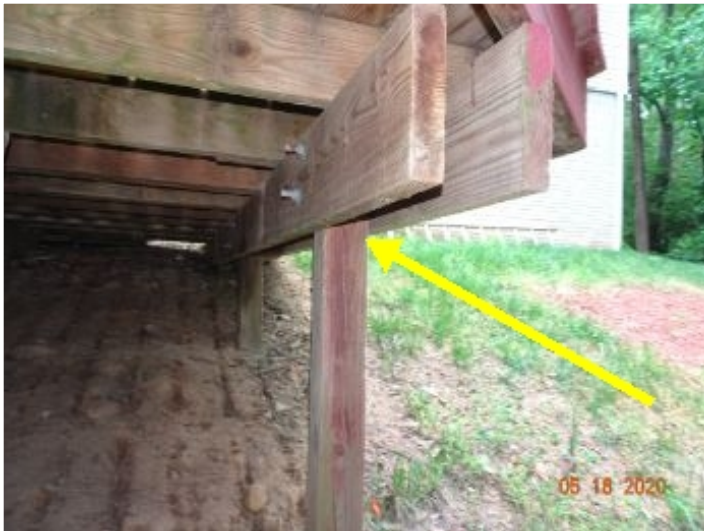
The deck beams are improperly attached to the support posts. The posts must fully support the downward weight of the deck. As such, beams attached to the sides of the support posts, as opposed to resting in notches in the post itself, cannot be expected to fully support the weight of the deck. This is a significant safety hazard and should be corrected to avoid potential deck collapse.

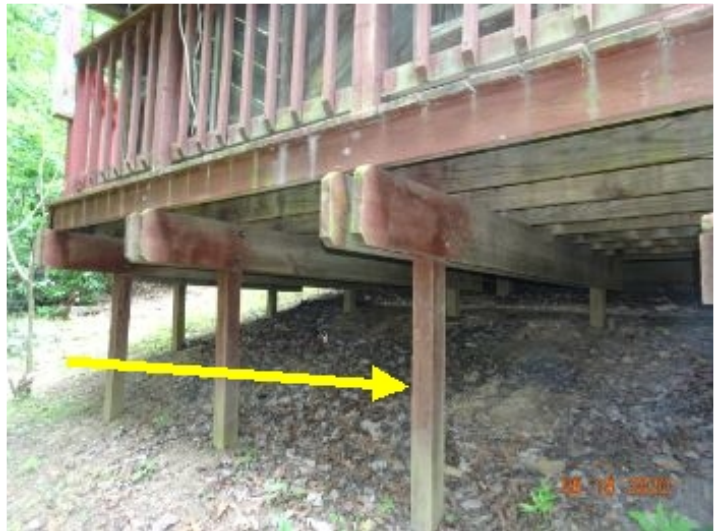
The post holding up the deck are made with 4 x 4 post. The current minimum acceptable size is a 6 x 6. More support should be added to keep the deck safe.
